2. A Challenge

3. What we found

Craig M. Bennett, Jr., PE, SE
Bennett Preservation Engineering PC

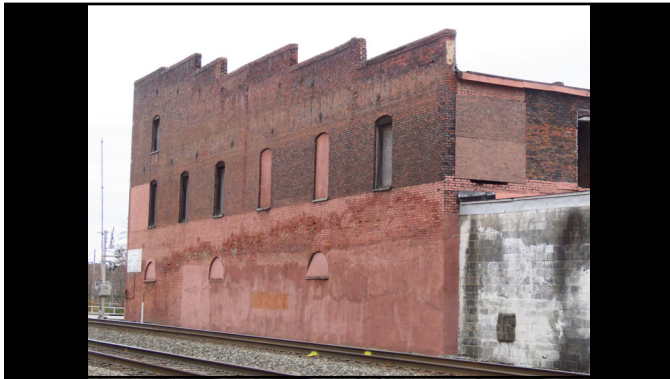
- Roof had partially collapsed to the 3rd floor

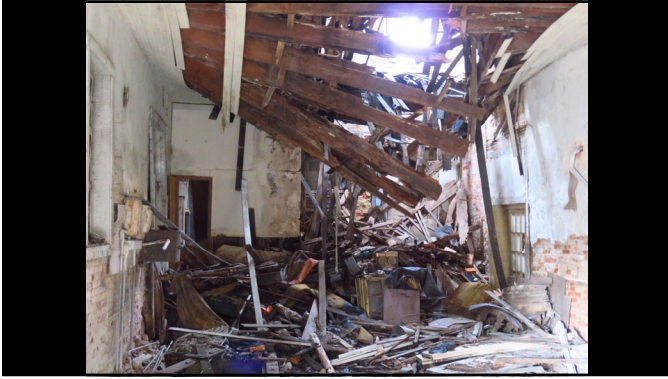
- 2nd floor had partially collapsed to the ground

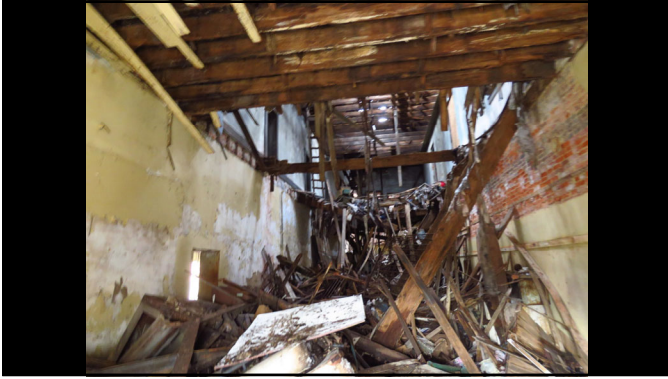
- Leaving three brick flags waving in the breeze, each 100 feet deep and 40 feet high

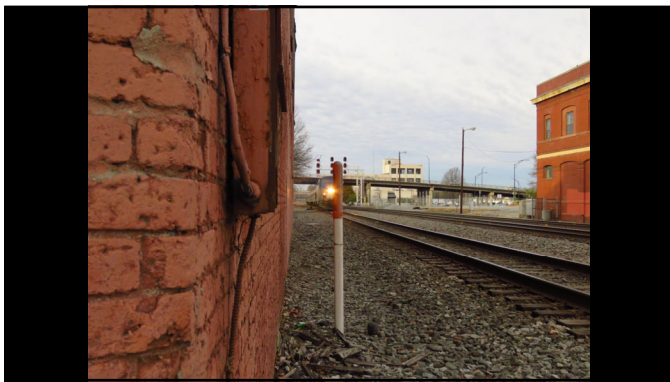
- North of building – high speed Amtrack line 10'-0" away

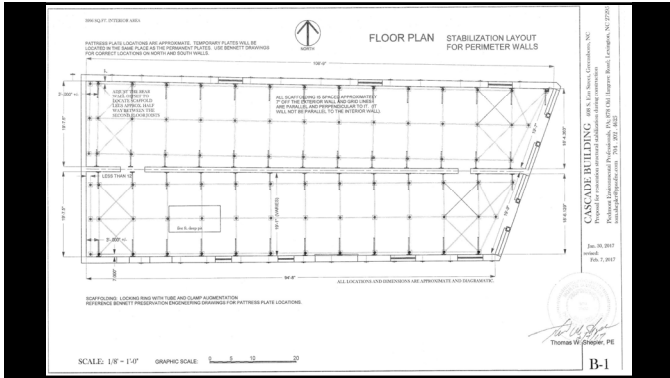
- Building had little lateral load capability in the short direction, north-south
- Wood had not survived
- The masonry was the last man standing
