**Early Strength Performance of Laps Splices of Rebar in Masonry**

W. Mark McGinley, Ph. D., PE FASTM, FTMS  
TMS Annual Meeting October 17 , 2024

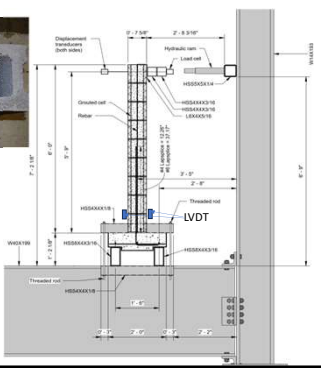
**TEST PROGRAM**

(15) #4 steel rebar  
(15) #6 rebar.

Lap splice length of 12.3 in for the #4 37.2 in lap splices for the #6 rebar.

The walls were grouted and tested after allowing the grout to cure for 12 hours, 24 hours, 4 days and 28 days in lab air. 3 replicants

Grout compression specimens made for each wall

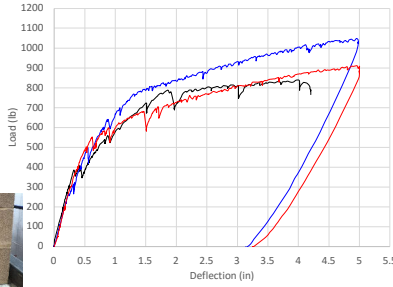
**28 day Walls # 4 Rebar (Control)**

Load vs Deflection

| Wall 1 | 839 lb |
| Wall 2 | 1048 lb |
| Wall 3 | 911 lb |
| Average | 933 lb |
| STD | 86.9 lb |
| COV | 9.32% |

Grout 4827 – 8144 psi

Reinforced Wall Test Maximum Wall Load Results for # 4 Rebar & 28-dayPred (full yield).

| Wall Specimen | Pmax (lb.) | Pmax/Ppred.28d | Average Load (lb.) | Coefficient of Variation |
|---|---|---|---|---|
| 28-day grout #1 | 839 | 1.321 | 933 (1.74) | 9.3% |
| 28-day grout #2 | 1048 | 1.651 | | |
| 28-day grout #3 | 911 | 1.435 | | |

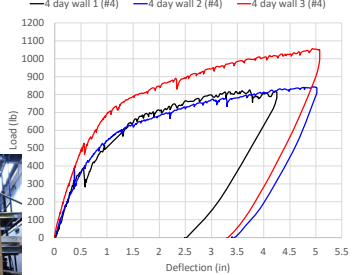
**4 day walls #4 Rebar**

Load vs Deflection

| Wall 1 | 825 lb |
| Wall 2 | 844 lb |
| Wall 3 | 1056 lb |
| Average | 908 lb |
| STD | 128 lb |
| COV | 14% |

Grout 3527 – 5691 psi

| Wall Specimen | Pmax (lb.) | Pmax/Ppred.28d | Average Load (lb.) | Coefficient of Variation |
|---|---|---|---|---|
| 4-day grout #1 | 825 | 1.299 | 908 (1.43) | 11.5% |
| 4-day grout #2 | 844 | 1.329 | | |
| 4-day grout #3 | 1056 | 1.663 | | |

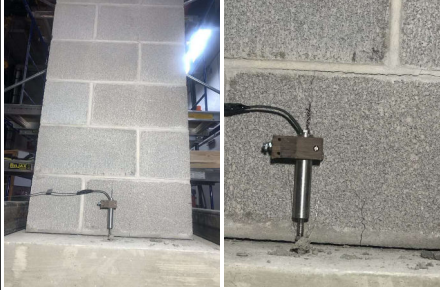
**Test 1: 12 Hour High-Early Grout #4 rebar**

- Grout reached 1093 psi.
- Maximum wall load was 801 lb.
- Maximum deflection at point load was 2.2 inches.
- Failure occurred primarily at the base.
- Vertical cracking mid height

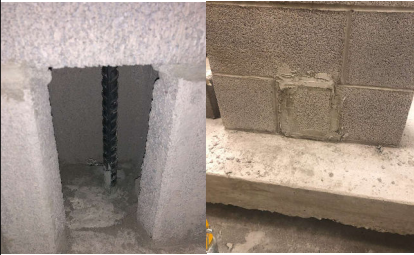
**#6 REBAR Clean outs**

- Cleanouts were cut into all (15) # 6
- Cut section was mortared back into place on the compression side of the wall.
- Some blowouts occurred during grouting and were repaired, loads seemed to be unaffected.
