2. A Challenge

3. What we found

Craig M. Bennett, Jr., PE, SE
Bennett Preservation Engineering PC

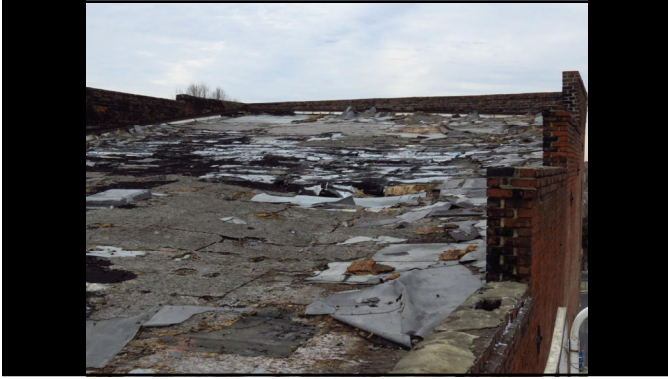
18

- Roof had partially collapsed to the 3rd floor

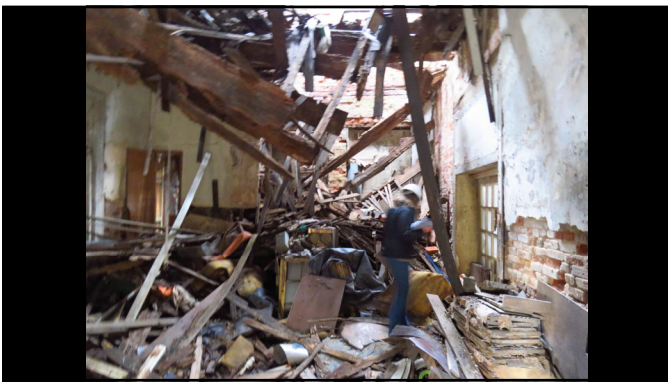
25

- 2nd floor had partially collapsed to the ground

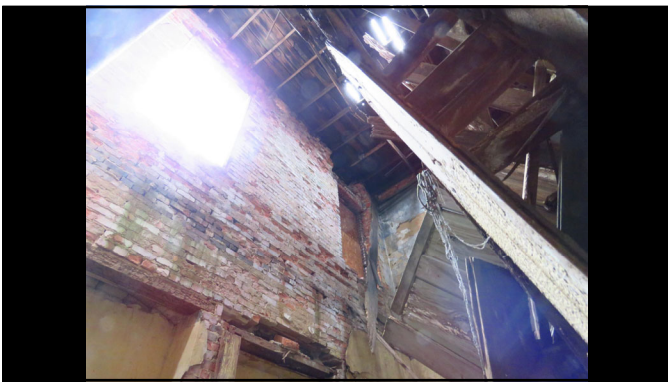
28

- Leaving three brick flags waving in the breeze, each 100 feet deep and 40 feet high

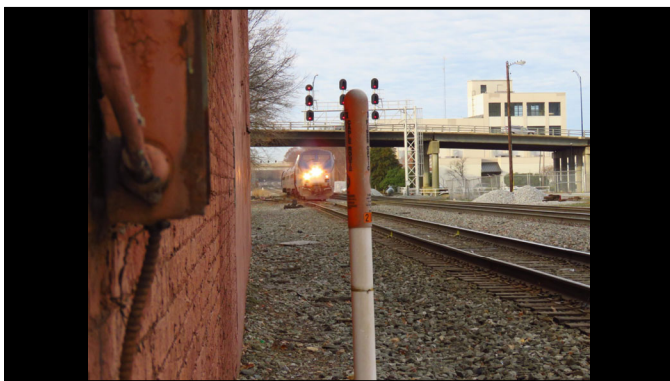
32

- North of building – high speed Amtrack line 10'-0" away

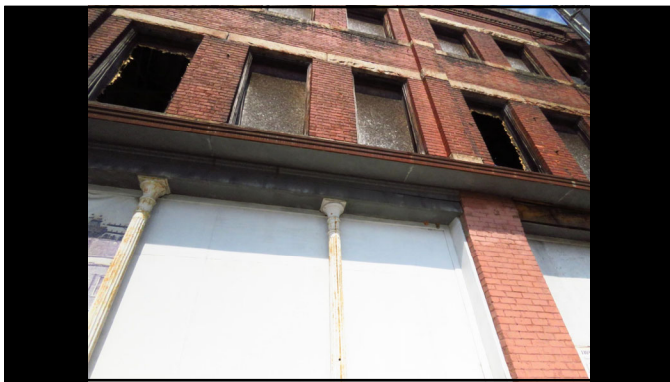
37

- Building had little lateral load capability in the short direction, north-south
- Wood had not survived
- The masonry was the last man standing
